**GEM ENVIRONMENTAL, INC.**

## **ASBESTOS AND LEAD-CONTAINING PAINT** **INSPECTION REPORT**

**SITE:**  
**Former Missoula County Youth Court**  
**311 Woody St. Missoula, MT, 59802**

**Report Date: July 06, 2026**  
**Revision: 1.0**

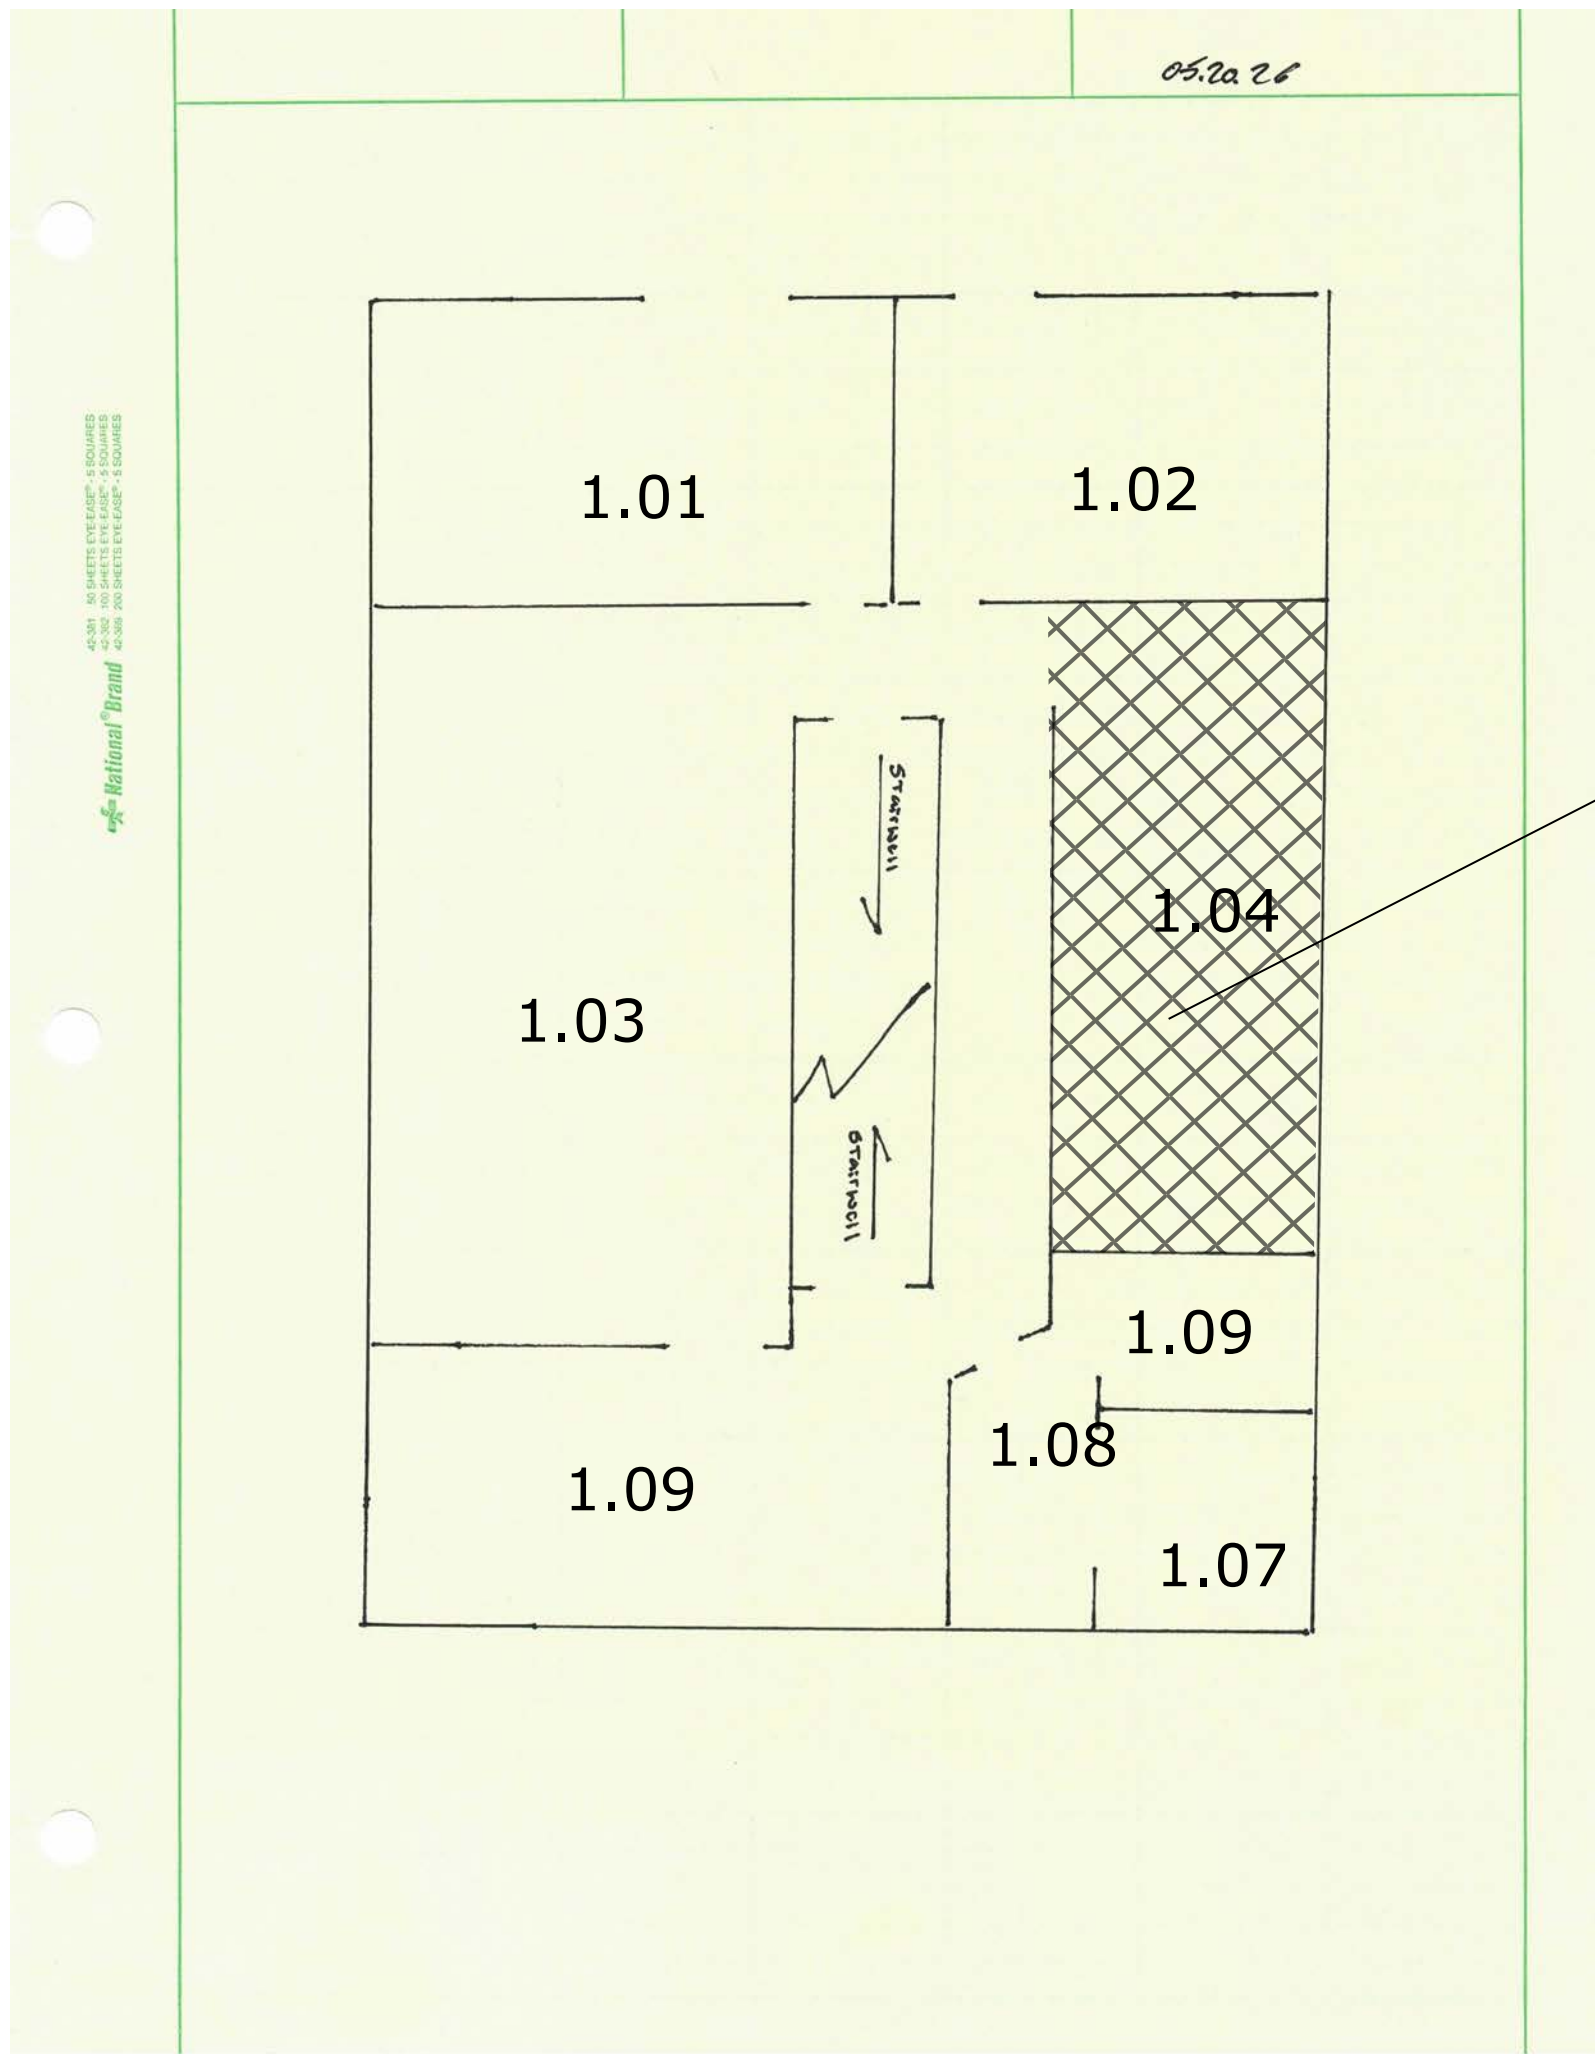
Figure 2: Locations of Confirmed and Suspect Asbestos-Containing Materials Technical building plan showing functional spaces with confirmed and assumed ACM present (cross-hatched patterns). Numbered labels correspond to homogeneous area (HA) IDs in Table 1 (suspect and confirmed materials summary). Number color indicates current observed condition and disturbance potential (see legend below). × indicates cross-contaminated homogeneous areas (special handling required). Full details, including condition assessment, disturbance potential, regulatory category, and recommended response actions, are provided in Table 1.

Number color = Condition / Disturbance Risk (detailed in Table 3):  
Red = Poor condition / High priority (immediate abatement recommended)  
Yellow = Fair condition / Medium priority (repair or encapsulation at renovation)  
Green = Good/Intact condition / Low priority (ongoing O&M program)

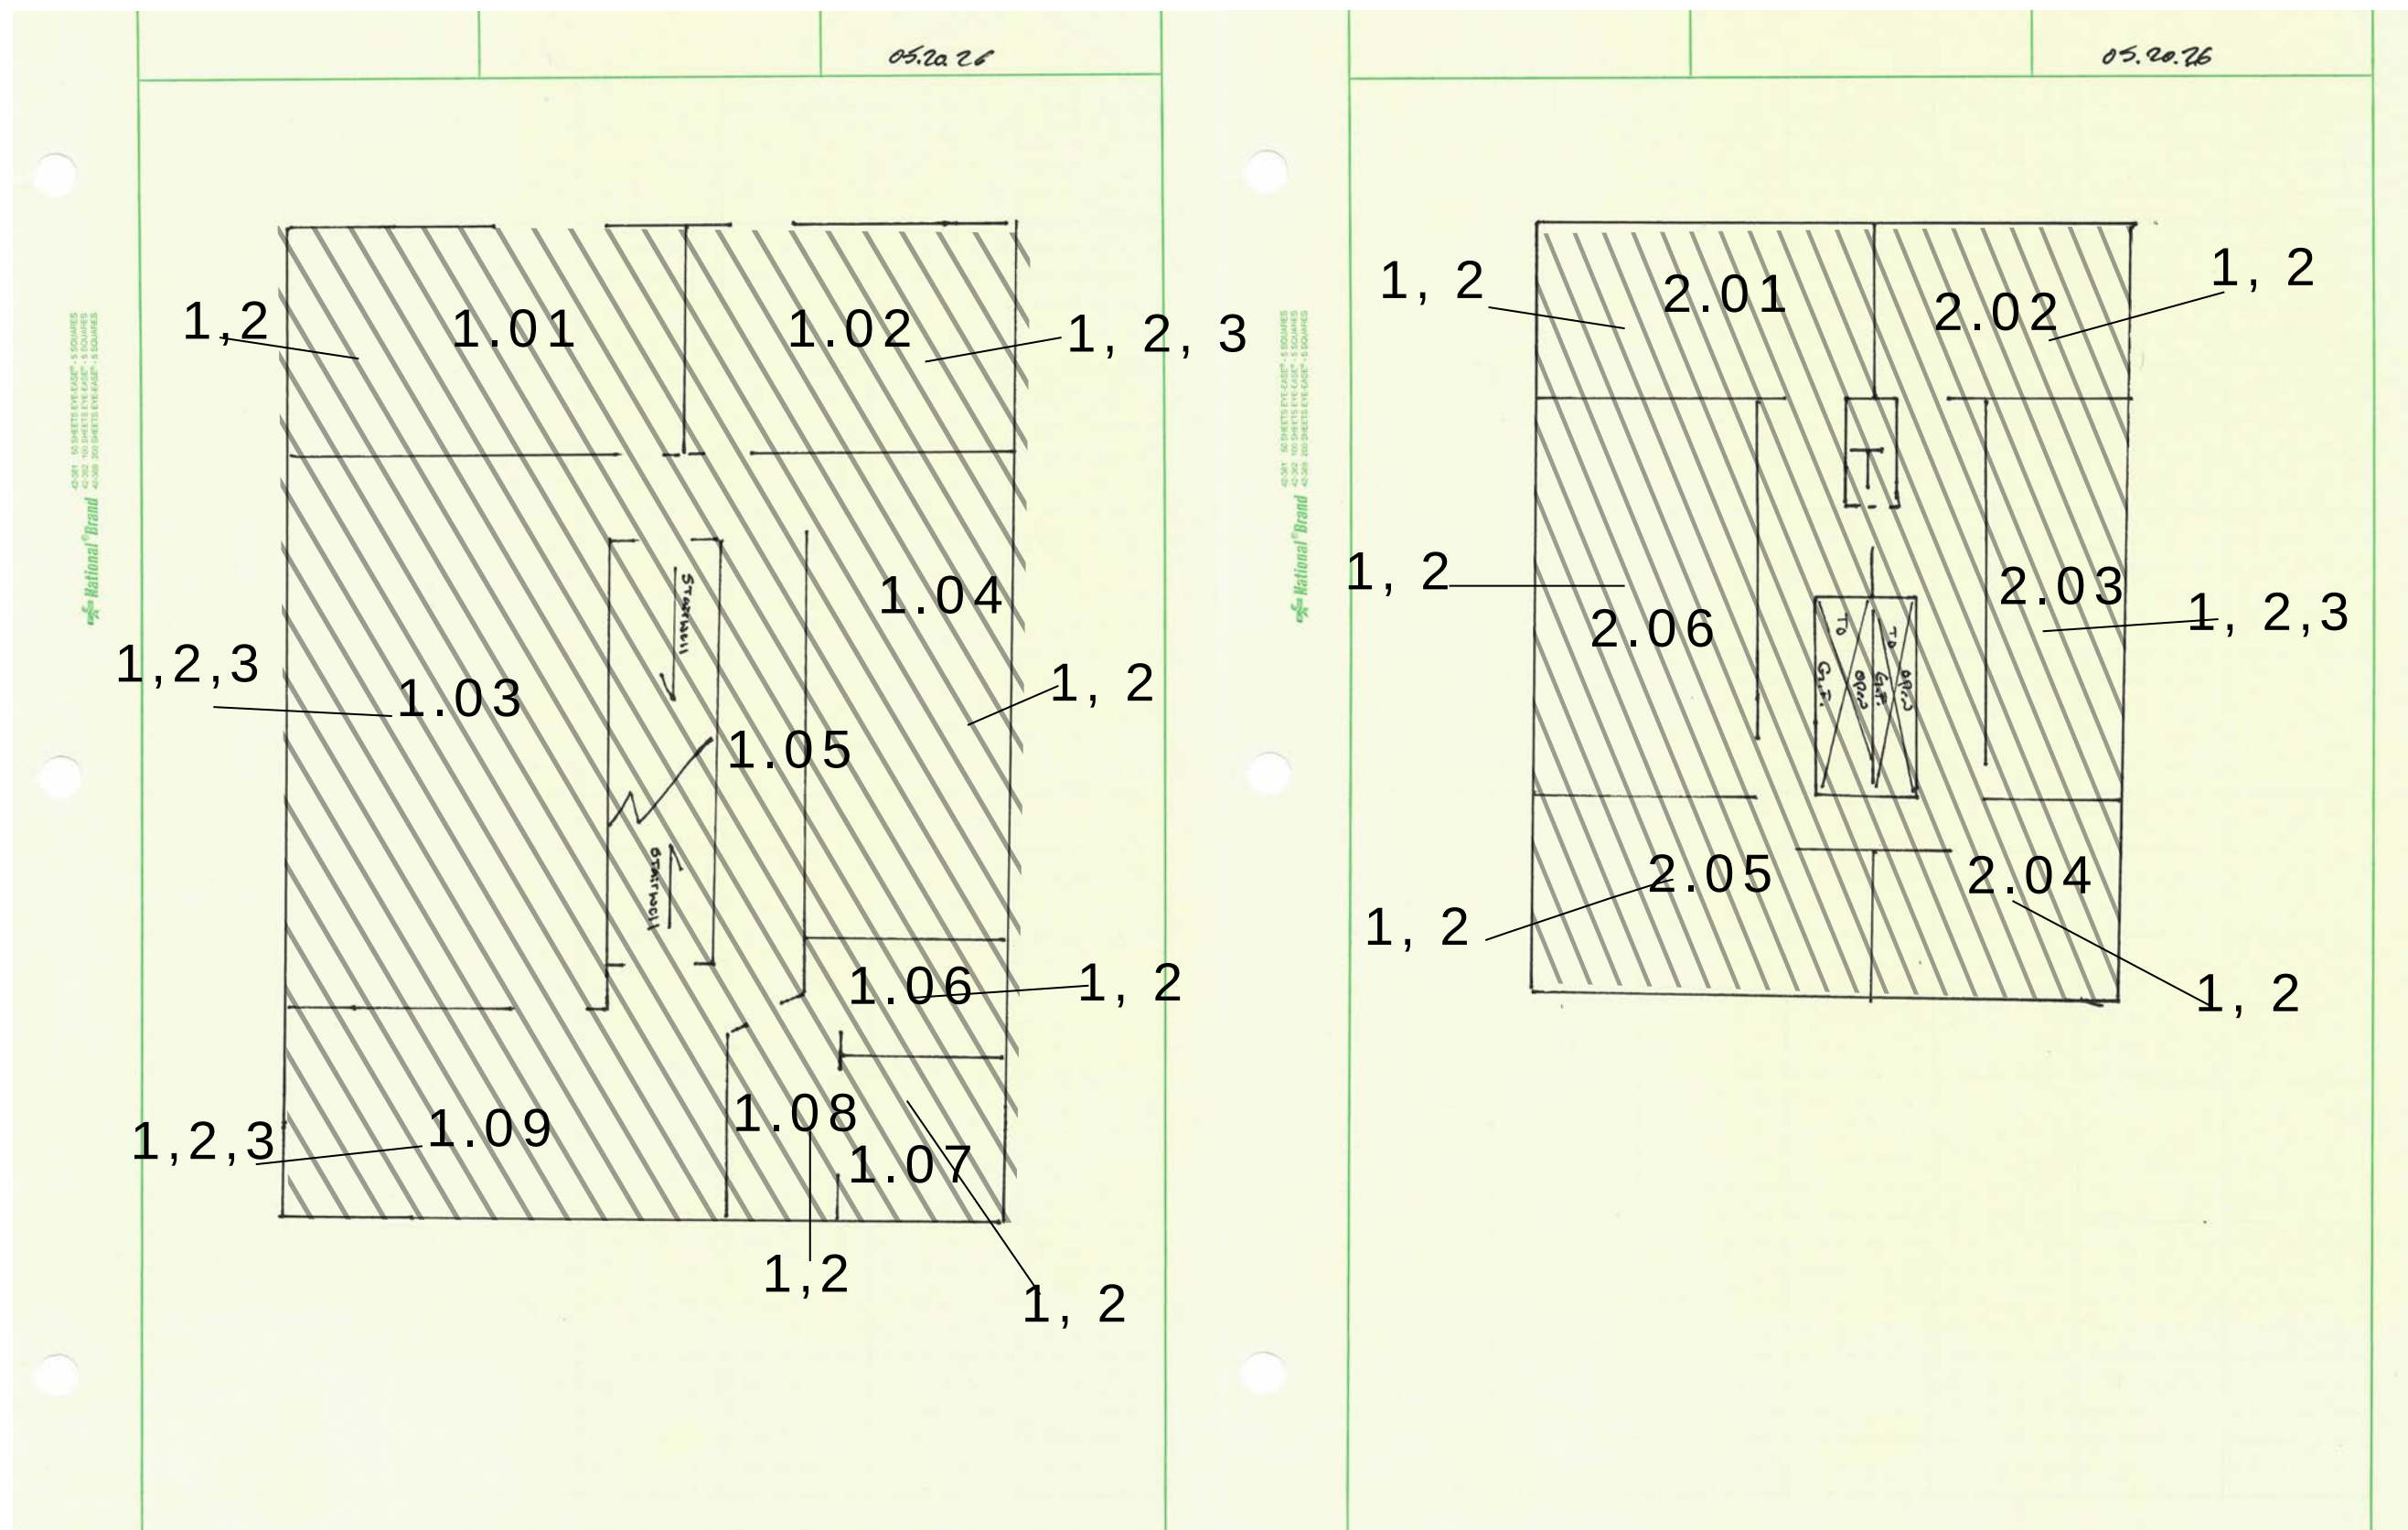
Figure 3: Locations of Confirmed Lead-Containing Paint/Coatings Technical building plan showing functional spaces with confirmed and suspect lead-containing paint/coatings (LCP/LBP) present (cross-hatched patterns). Numbered labels correspond to homogeneous area (HA) IDs in Table 2 (suspect and confirmed painted surfaces summary). Number color indicates current observed condition and disturbance potential (see legend below). x indicates cross-contaminated or high-risk painted areas (special handling required). Full details, including condition assessment, disturbance potential, and recommended response actions, are provided in Table 4.

Legend:  
Cross-hatch patterns indicate functional space groups with LCP/LBP present:  
Dense double cross-hatch = High-risk / Deteriorated areas  
Single diagonal hatch = Category I Non-Friable (e.g., intact coatings)  
Vertical lines = Category II Non-Friable (e.g., brittle or cementitious)

Number color = Condition / Disturbance Risk (detailed in Table 4):  
Red = Poor condition / High priority (immediate or delayed abatement during next renovation recommended)  
Yellow = Fair condition / Medium priority (repair or encapsulation at renovation)  
Green = Good/Intact condition / Low priority (ongoing O&M program)

- P.4:** Red paint applied to the original wood Tongue and groove flooring, throughout the offices section (offices, corridors, common rooms) on the main/2<sup>nd</sup> levels. This HA contains 2.6 mg of lead per one square centimeter.
  - Note:** New floor coverings have been installed over the P.4 with glue/adhesives any attempt to remove the overlying floor coverings will disturb P.4 and potentially create a hazardous lead dust.
- P.2:** Peach top coat over beige/white base coat (0.2 mg/cm<sup>2</sup>) on the original plaster wall/ceiling coverings throughout the offices, corridors, common rooms on the main/2<sup>nd</sup> levels.
- P.3:** White to coat with maroon base coat (0.7 mg/cm<sup>2</sup>), applied to the textile wall coverings in rooms 1.09, 1.03, 1.02, 2.03.
