**GEM ENVIRONMENTAL, INC.**

## **ASBESTOS AND LEAD-CONTAINING PAINT** **INSPECTION REPORT**

**SITE:**  
**Former Missoula County Youth Court**  
**311 Woody St. Missoula, MT, 59802**

**Report Date: July 06, 2026**  
**Revision: 1.0**

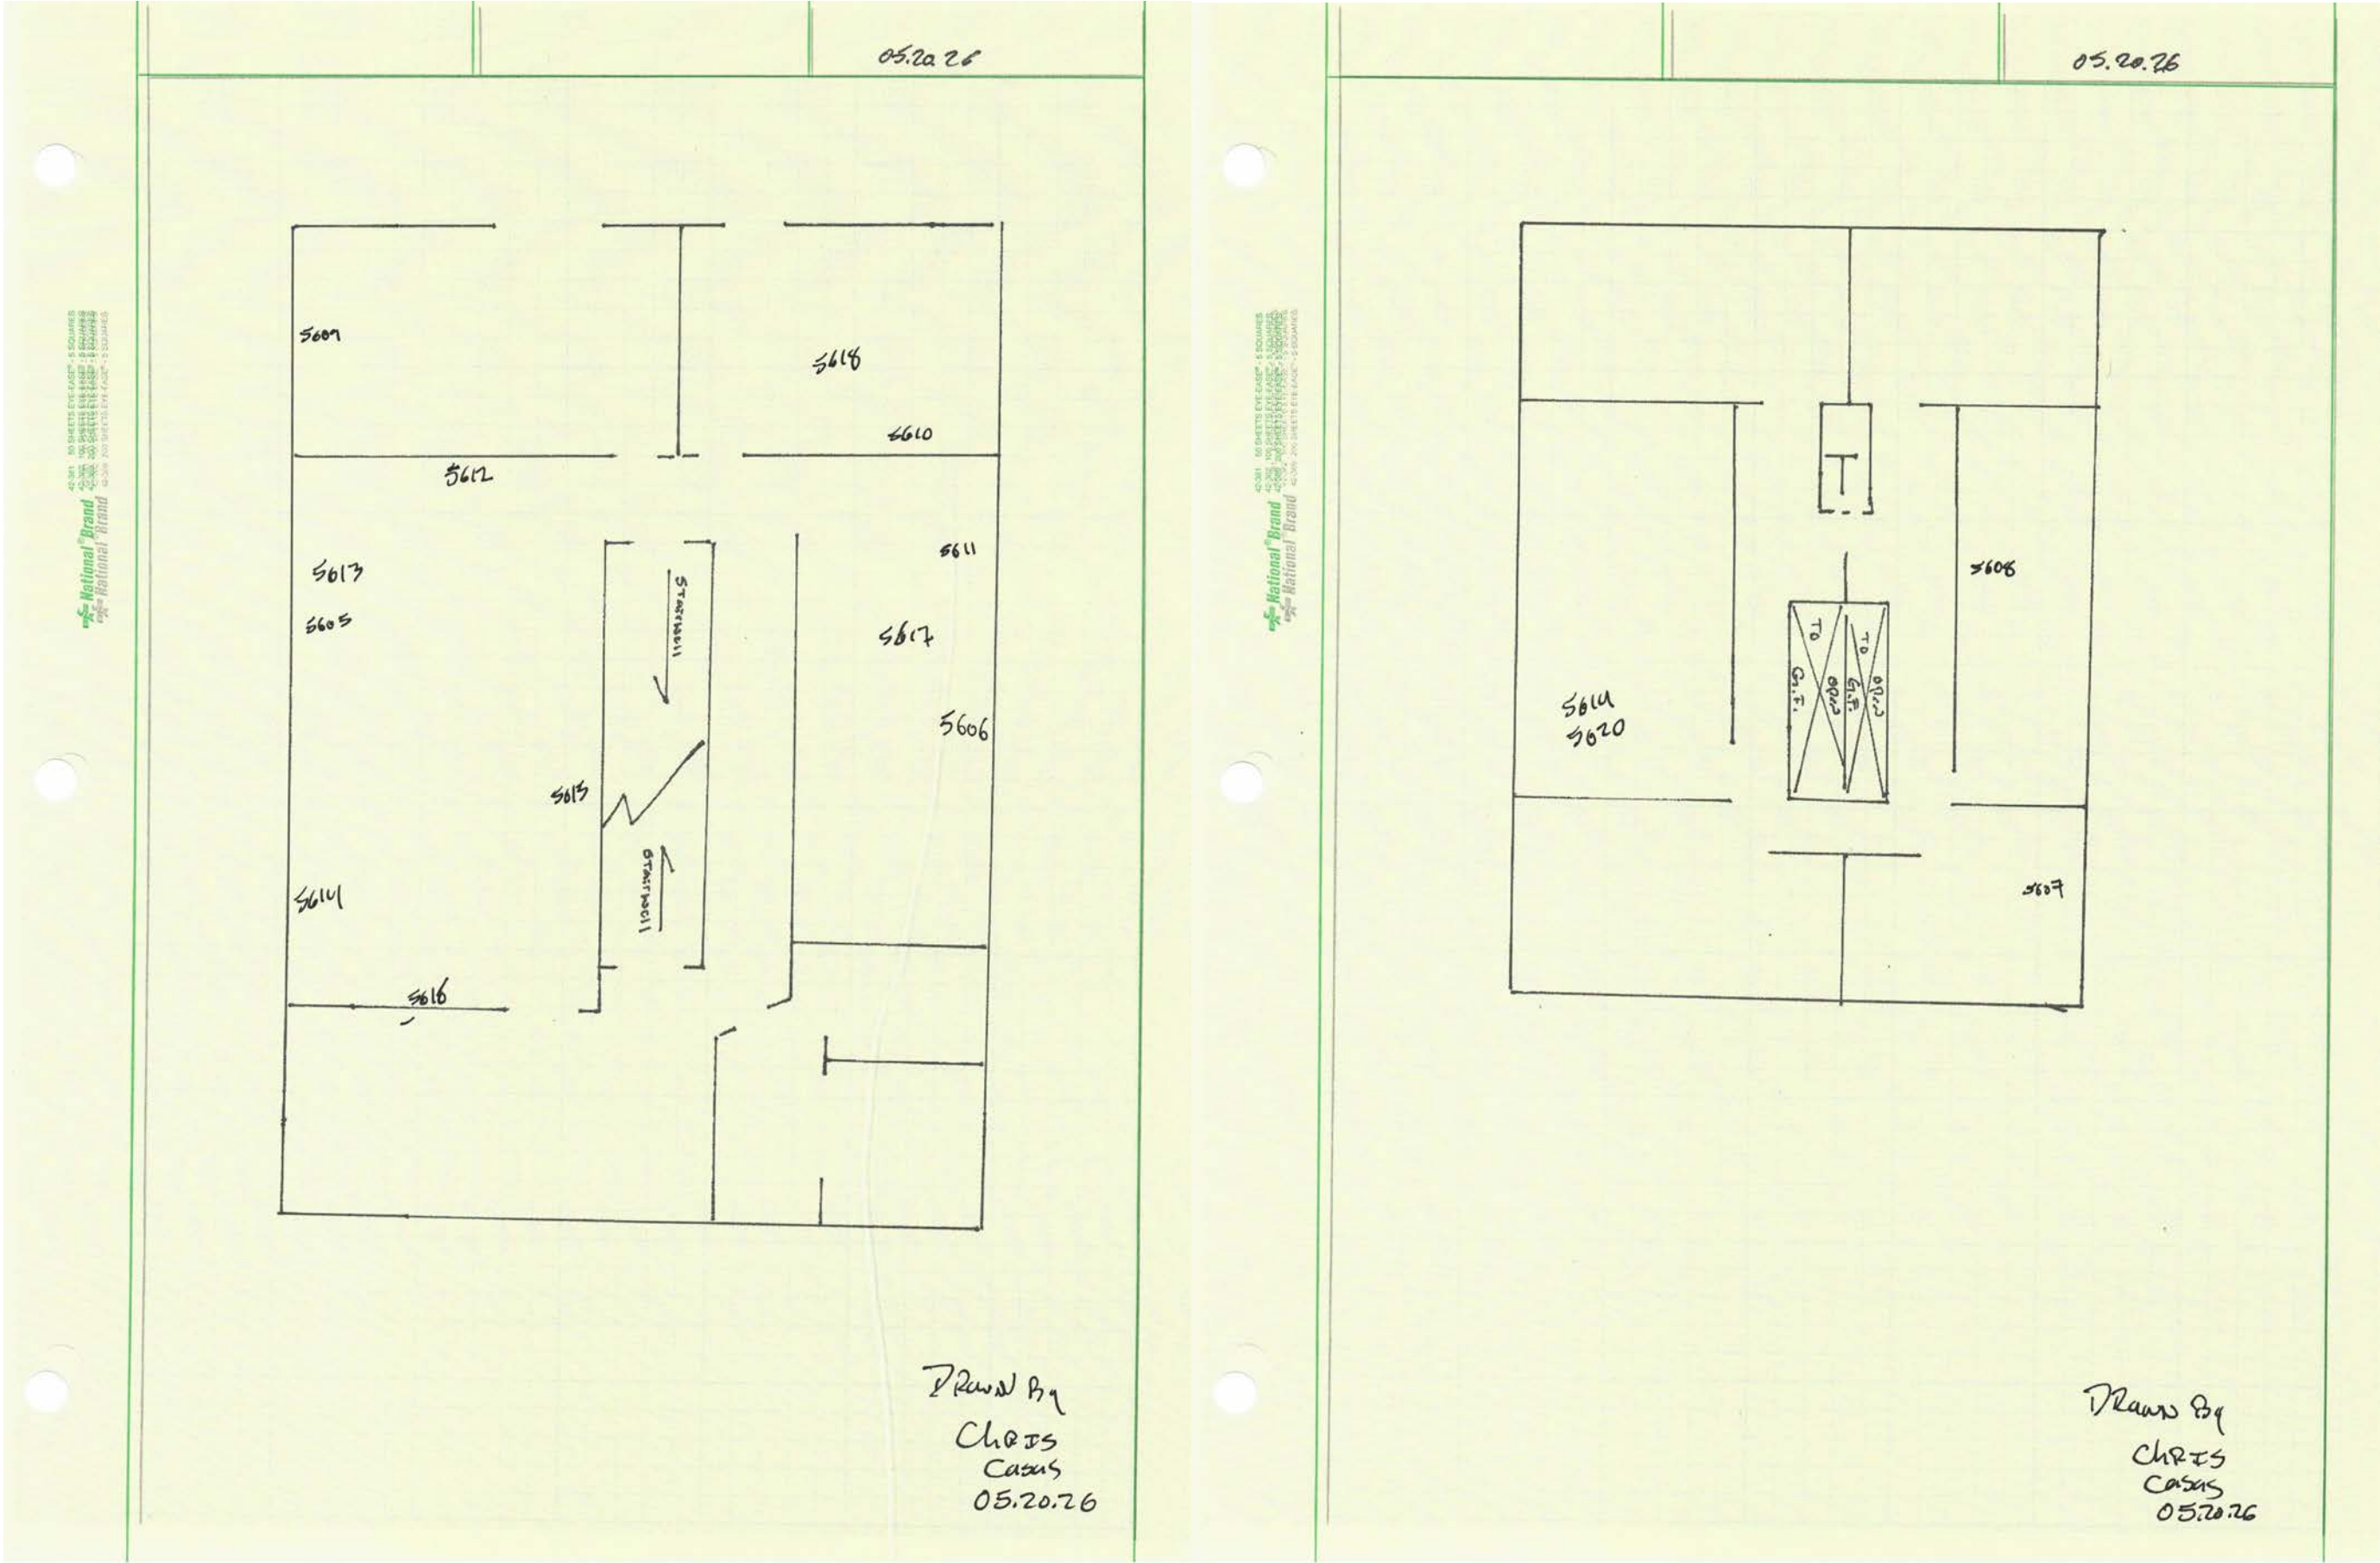
Sheet Number: NO 1

Figure 2: Locations of Confirmed and Suspect Asbestos-Containing Materials Technical building plan showing functional spaces with confirmed and assumed ACM present (cross-hatched patterns). Numbered labels correspond to homogeneous area (HA) IDs in Table 1 (suspect and confirmed materials summary). Number color indicates current observed condition and disturbance potential (see legend below). × indicates cross-contaminated homogeneous areas (special handling required). Full details, including condition assessment, disturbance potential, regulatory category, and recommended response actions, are provided in Table 1.
